**Flood Control Project Maintenance
Levee Inspections
LMA District Cover Sheet
Spring 2010 Levee Inspection Results**

Reclamation District No. 0524 Middle Roberts Island

Levee Inspection Report By Mile - Spring 2010

Waterway						Bank	Unit Miles	Inspection Start/End	Inspector
Unit No. 01 San Joaquin River						Left	6.26	03/30/2010 04/05/2010	Richard Willoughby

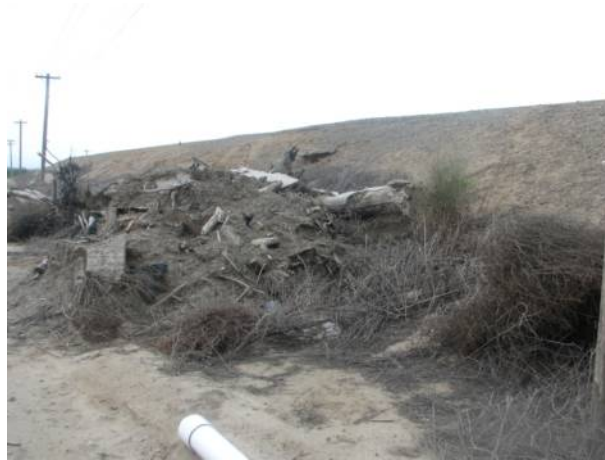
Levee Mile Report Line	5
Start Levee Mile	0.38
End Levee Mile	0.39
Location	Water Side
Category	Earthen Levee
Item	Erosion / Bank Caving

Minor erosion from LM 0.38 to 0.39

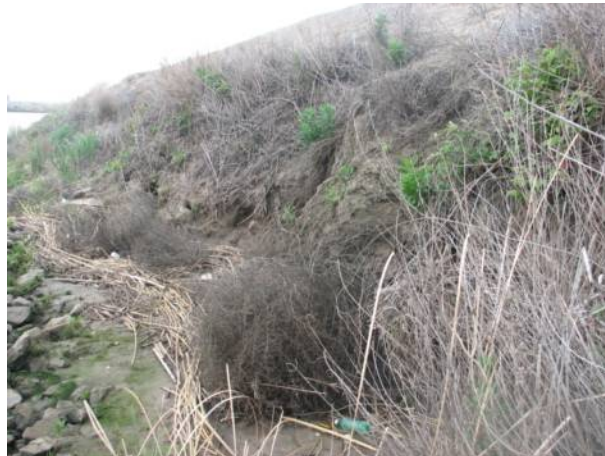
Levee Mile Report Line	7
Start Levee Mile	0.48
End Levee Mile	0.49
Location	Water Side
Category	Earthen Levee
Item	Erosion / Bank Caving

Major erosion from LM 0.48 to 0.49

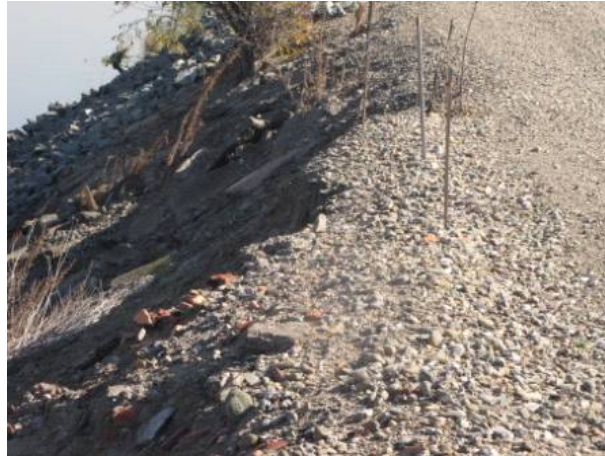
Levee Mile Report Line	7
Start Levee Mile	0.48
End Levee Mile	0.49
Location	Water Side
Category	Earthen Levee
Item	Erosion / Bank Caving

Looking southeast at erosion (no change as 4/2010)

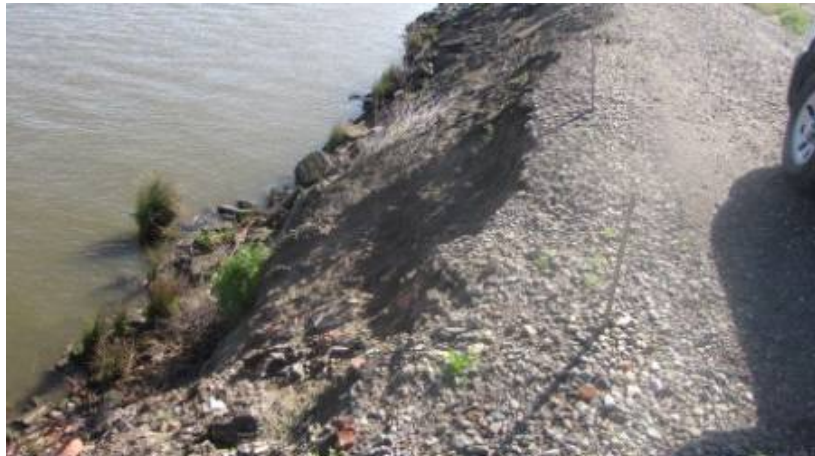
Levee Mile Report Line	7
Start Levee Mile	0.48
End Levee Mile	0.49
Location	Water Side
Category	Earthen Levee
Item	Erosion / Bank Caving

Looking at erosion from the top of the levee (no change as of 4/2010)

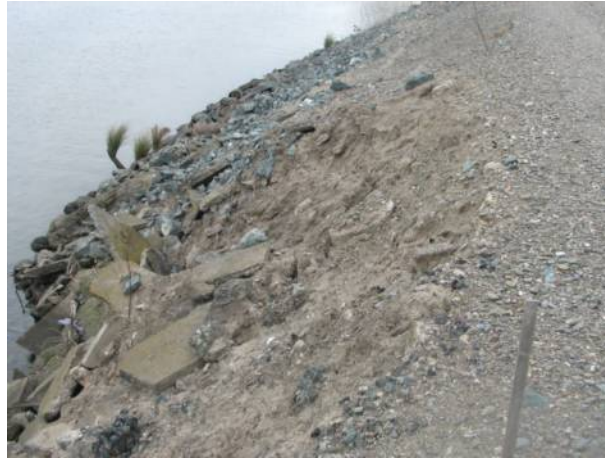
Levee Mile Report Line	8
Start Levee Mile	0.51
End Levee Mile	0.52
Location	Water Side
Category	Earthen Levee
Item	Erosion / Bank Caving

Update of erosion site at LM 0.51 to 0.52

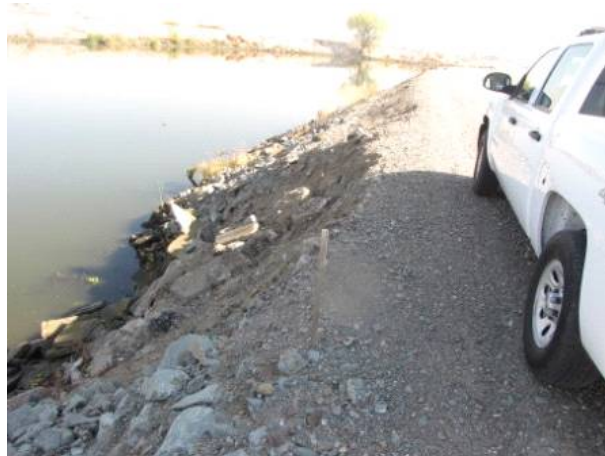
Levee Mile Report Line	8
Start Levee Mile	0.51
End Levee Mile	0.52
Location	Water Side
Category	Earthen Levee
Item	Erosion / Bank Caving

Looking southeast at erosion on waterside slope ,
no change as of 4/2010)

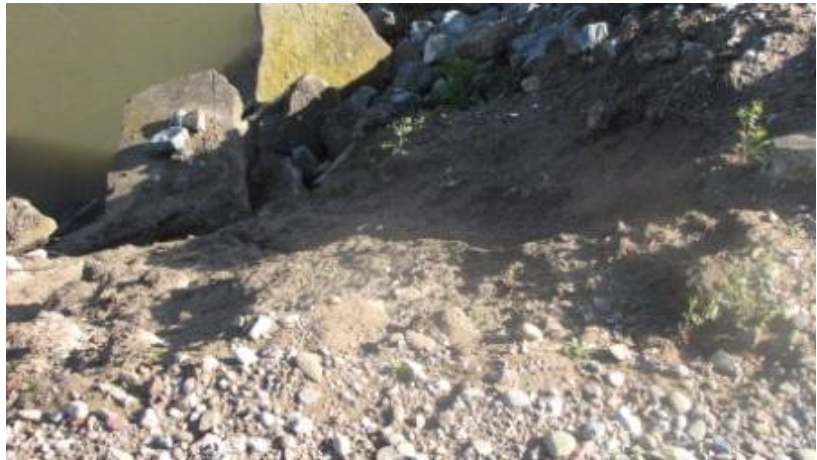
Levee Mile Report Line	9
Start Levee Mile	0.53
End Levee Mile	0.60
Location	Water Side
Category	Supplemental
Item	DWR Erosion Survey

2009: erosion site extends from RM 41.11 to 41.18; existing revetment is no longer adequately protecting the oversteepened slope [2009 SiteID:RD0524U1RM41.15]

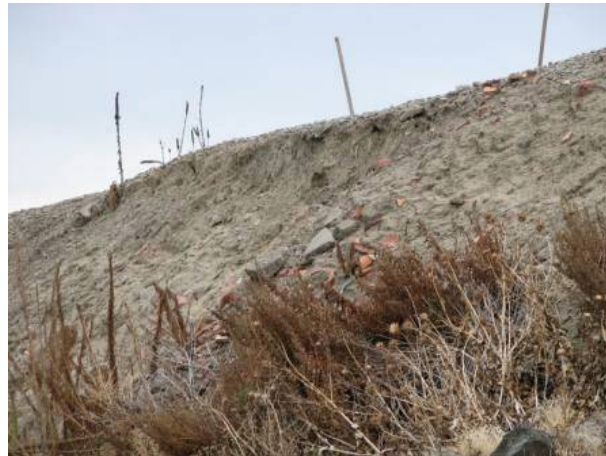
Levee Mile Report Line	9
Start Levee Mile	0.53
End Levee Mile	0.60
Location	Water Side
Category	Supplemental
Item	DWR Erosion Survey

2009: erosion site extends from RM 41.11 to 41.18; existing revetment is no longer adequately protecting the oversteepened slope [2009 SiteID:RD0524U1RM41.15]

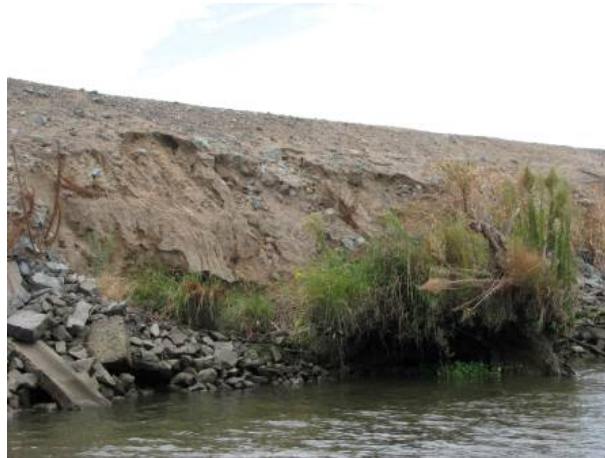
Levee Mile Report Line	9
Start Levee Mile	0.53
End Levee Mile	0.60
Location	Water Side
Category	Supplemental
Item	DWR Erosion Survey
2009: erosion site extends from RM 41.11 to 41.18; existing revetment is no longer adequately protecting the oversteepened slope [2009 SiteID:RD0524U1RM41.15]	
SJR2009_RM41.18 092909B.JPG

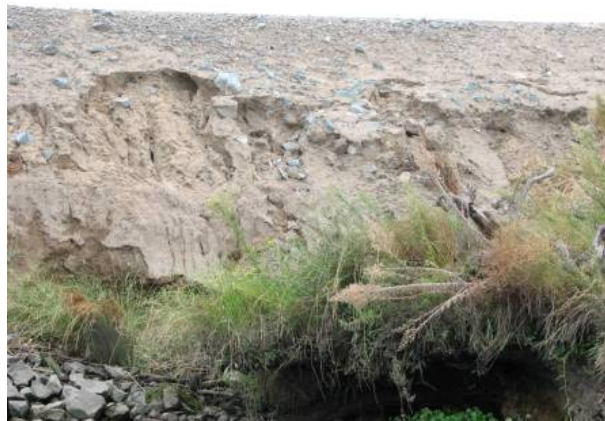
Levee Mile Report Line	9
Start Levee Mile	0.53
End Levee Mile	0.60
Location	Water Side
Category	Supplemental
Item	DWR Erosion Survey
2009: erosion site extends from RM 41.11 to 41.18; existing revetment is no longer adequately protecting the oversteepened slope [2009 SiteID:RD0524U1RM41.15]	
SJR2009_RM41.18 092909C.JPG

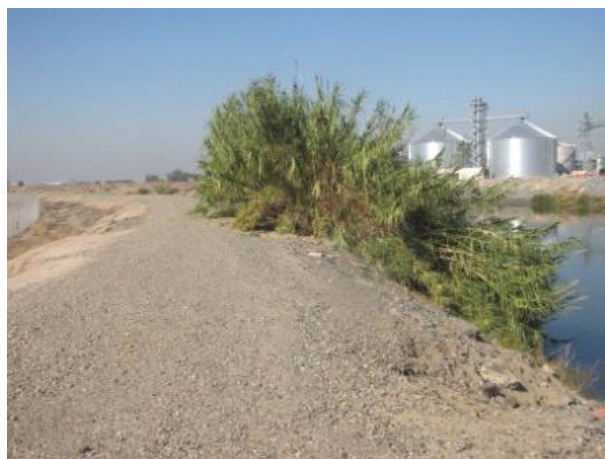
Levee Mile Report Line	11
Start Levee Mile	0.63
End Levee Mile	0.64
Location	Water Side
Category	Earthen Levee
Item	Vegetation
Looking north at bamboo on waterside slope.	
richard_s_20100316_043.jpg

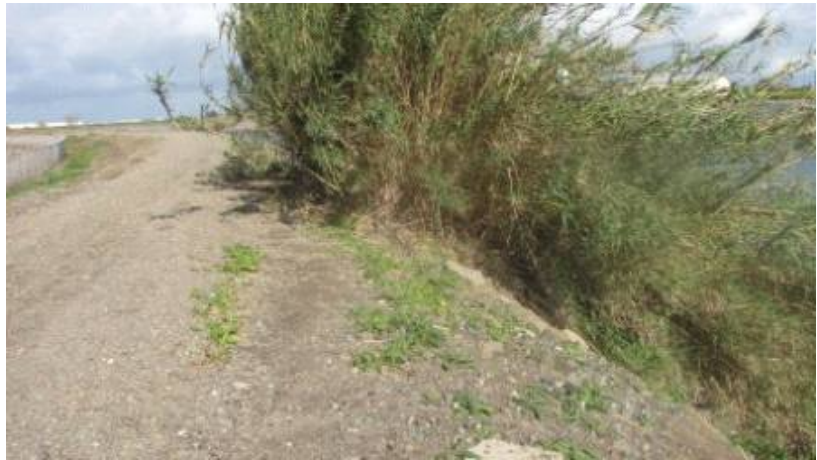
Levee Mile Report Line	12
Start Levee Mile	0.64
End Levee Mile	0.64
Location	Crown
Category	Earthen Levee
Item	Crown Surface / Depressions / Rutting

Large hole 3 x 3 on levee crown near waterside shoulder at LM 0.64

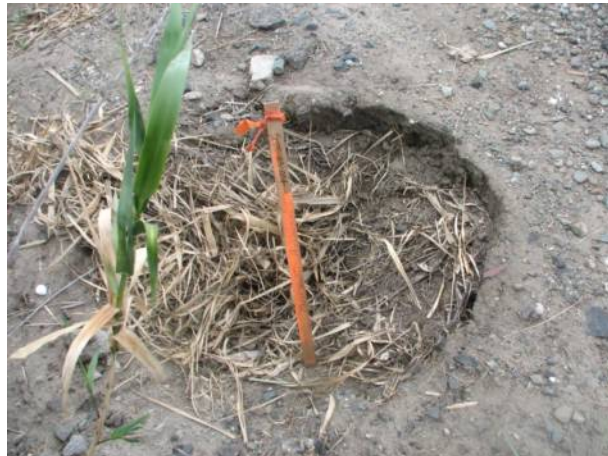
Levee Mile Report Line	13
Start Levee Mile	0.65
End Levee Mile	0.66
Location	Water Side
Category	Earthen Levee
Item	Slope Stability

Erosion from LM 0.65 to 0.66

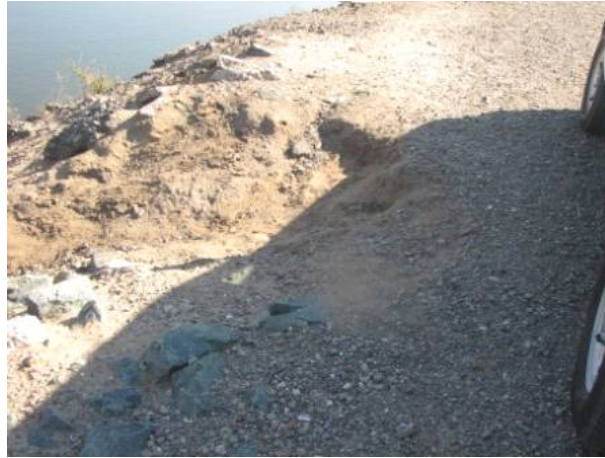
Levee Mile Report Line	13
Start Levee Mile	0.65
End Levee Mile	0.66
Location	Water Side
Category	Earthen Levee
Item	Slope Stability

Looking south at erosion on waterside shoulder.

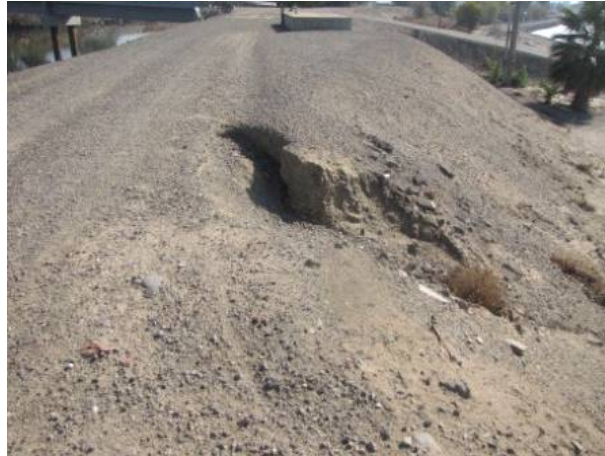
Levee Mile Report Line	19
Start Levee Mile	1.09
End Levee Mile	1.09
Location	Land Side
Category	Earthen Levee
Item	Slope Stability

Update of above slope stability.

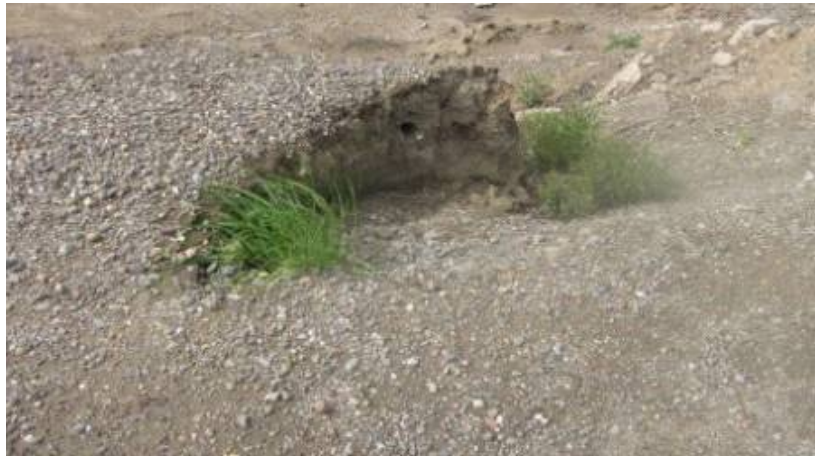
Levee Mile Report Line	19
Start Levee Mile	1.09
End Levee Mile	1.09
Location	Land Side
Category	Earthen Levee
Item	Slope Stability

Looking at updated slope stability as 4/2010

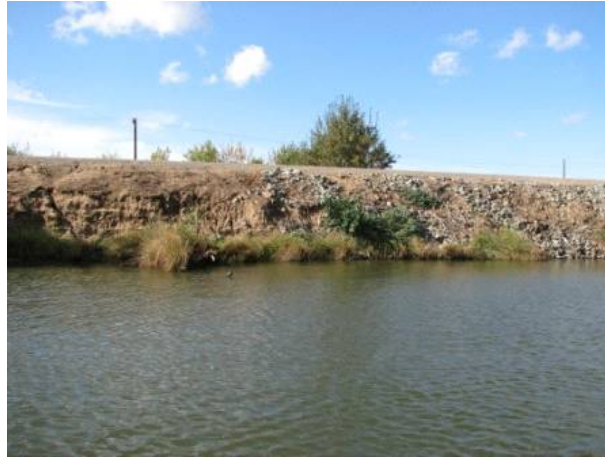
Levee Mile Report Line	22
Start Levee Mile	1.17
End Levee Mile	1.25
Location	Land Side
Category	Earthen Levee
Item	Vegetation

Looking southwest at dense veg. on landside toe.

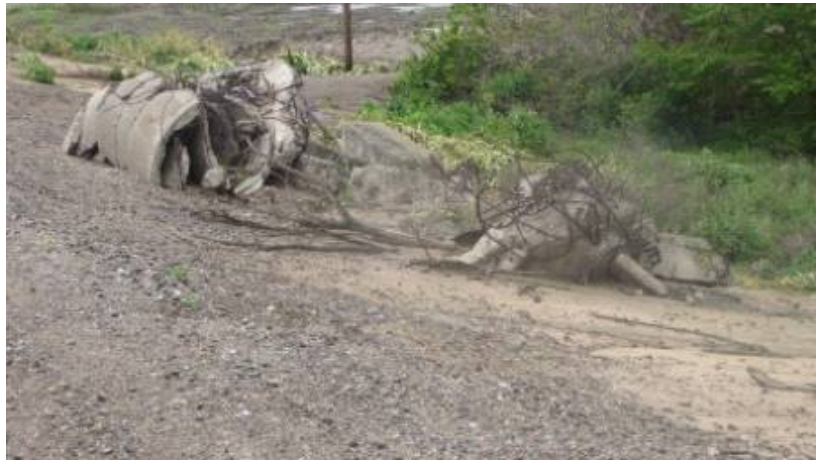
Levee Mile Report Line	24
Start Levee Mile	1.32
End Levee Mile	1.33
Location	Water Side
Category	Earthen Levee
Item	Erosion / Bank Caving

Erosion from LM 1.32 to 1.33

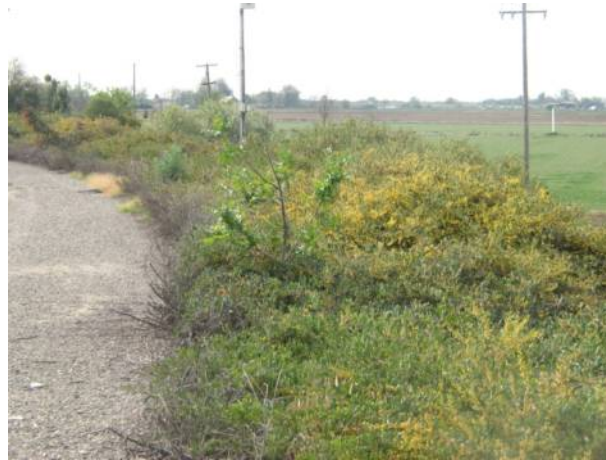
Levee Mile Report Line	27
Start Levee Mile	1.56
End Levee Mile	1.74
Location	Land Side
Category	Earthen Levee
Item	Encroachments
Overgrown landscaping on landward slope from LM 1.56 to 1.74	
richard_s_20100316_056.jpg

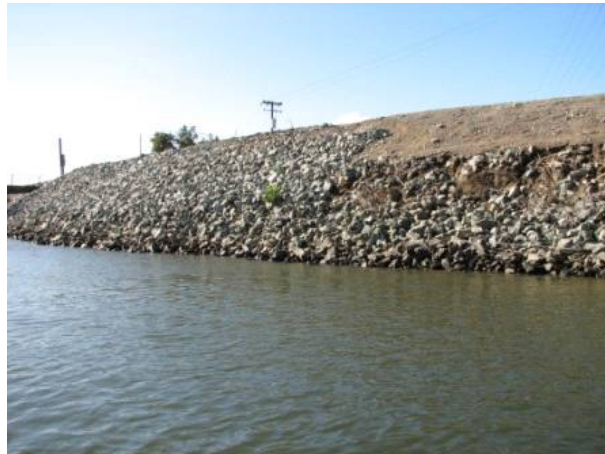
Levee Mile Report Line	102
Start Levee Mile	5.65
End Levee Mile	5.66
Location	Water Side
Category	Supplemental
Item	DWR Erosion Survey

2009: no major change observed; upper portion of the existing revetment has slipped, exposing the degraded bank; note the site # is same as RM 46.3, LM5.69 found in the CLRO CES Evaluation 2008 Report; ste was previously rated "M" [2009 SiteID:RD0524U1RM46.12]

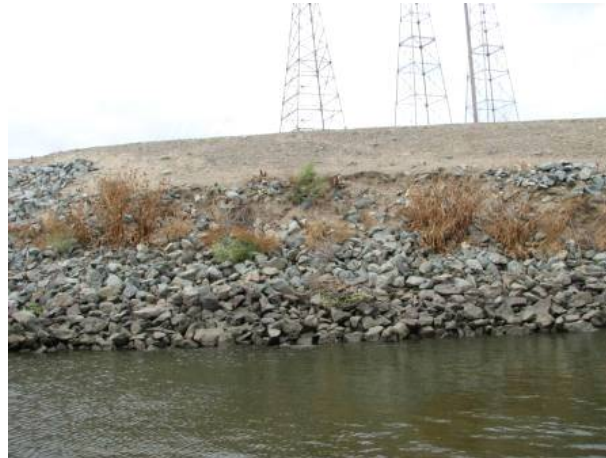
2009: no major change observed; upper portion of the existing revetment has slipped, exposing the degraded bank; note the site # is same as RM 46.3, LM5.69 found in the CLRO CES Evaluation 2008 Report; ste was previously rated "M" [2009 SiteID:RD0524U1RM46.12]

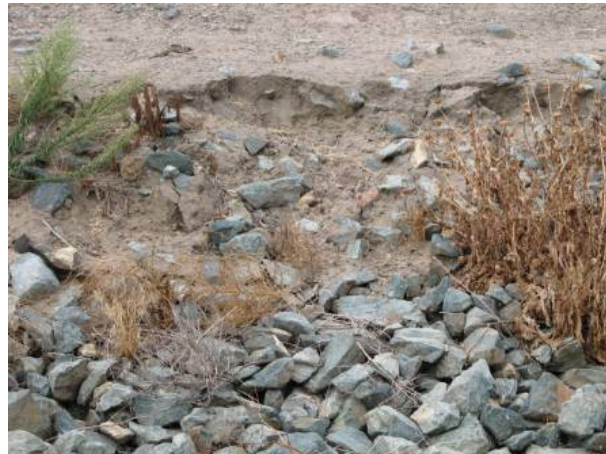
Levee Mile Report Line	102
Start Levee Mile	5.65
End Levee Mile	5.66
Location	Water Side
Category	Supplemental
Item	DWR Erosion Survey

2009: no major change observed; upper portion of the existing revetment has slipped, exposing the degraded bank; note the site # is same as RM 46.3, LM5.69 found in the CLRO CES Evaluation 2008 Report; ste was previously rated "M" [2009 SiteID:RD0524U1RM46.12]
